Manhole Inspection Summary

Manhole # S35A__015MH

Insp Date: **8/21/08 10:17 AM**

Location Address: **side 210 n guilford ave**

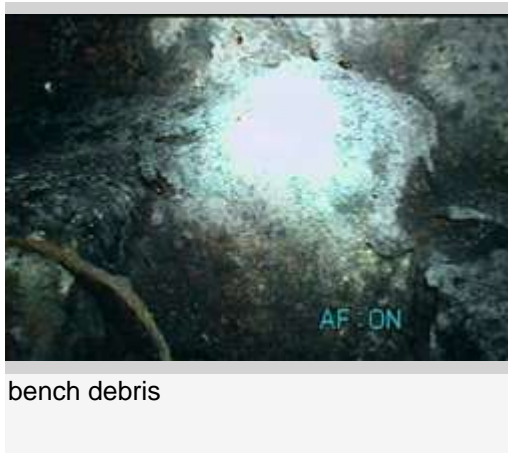
Defect 4

Bench

Condition: ☐ Sound ☐ Cracked ☐ Root Intrusion ☐ Deteriorated ☐ Leaks ☒ **Debris**

bench debris

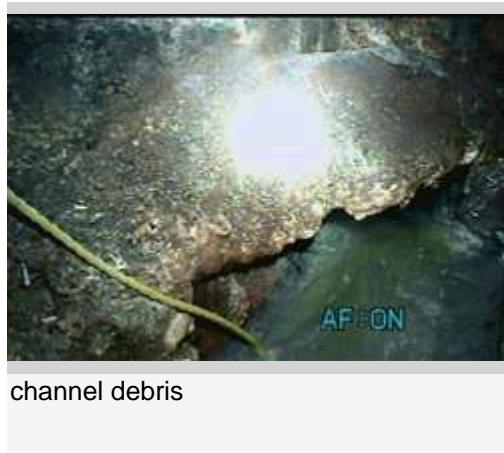
Defect 3

Condition: ☐ Sound ☐ Cracked ☐ Root Intrusion ☐ Deteriorated ☐ Leaks ☒ **Debris**

channel debris

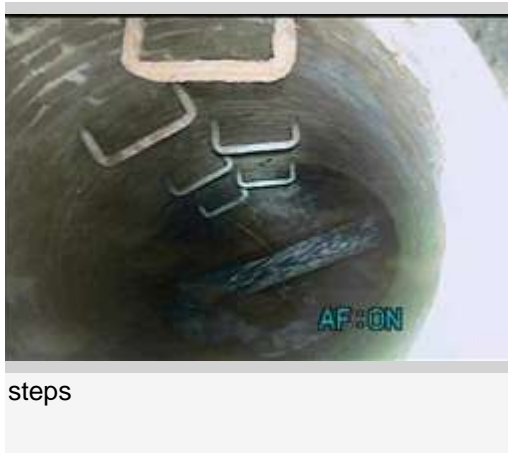
Defect 2

Count: **6** Missing: **0** ☒ **Corroded**

steps

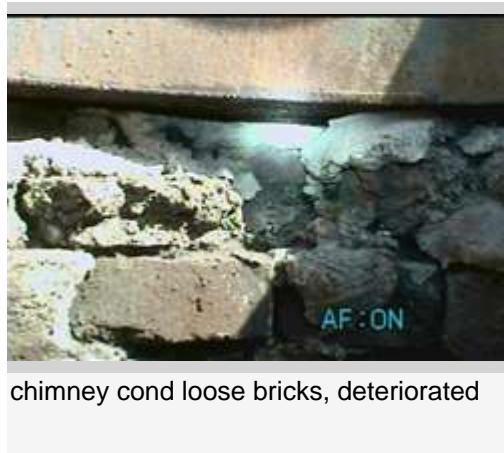
Defect 1

Condition: ☐ Sound ☐ Cracked ☐ Root Intrusion ☒ **Loose Brick** ☒ **Deteriorated**

chimney cond loose bricks, deteriorated

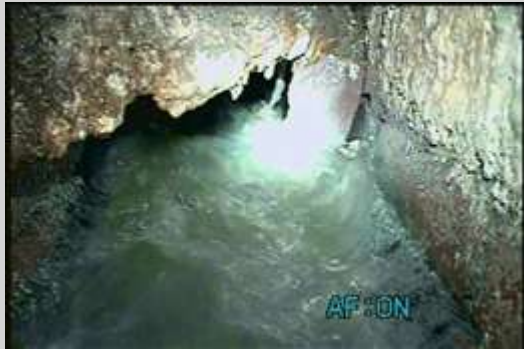
12 O'Clock Outflow

10 in. Circular Gravity Sewer
Pipe Out @ 12 O'Clock

Deposits: ☐ None ☐ Mud ☐ Sludge ☒ **Debris** ☐ Grease

Silt Depth: **5** (in.) Deposits Extent: **Medium**
